Edgar Wood and Middleton Townscape Heritage Initiative

## Jubilee Park Fountain, Middleton - Advice on Restoration

17<sup>th</sup> January 2015

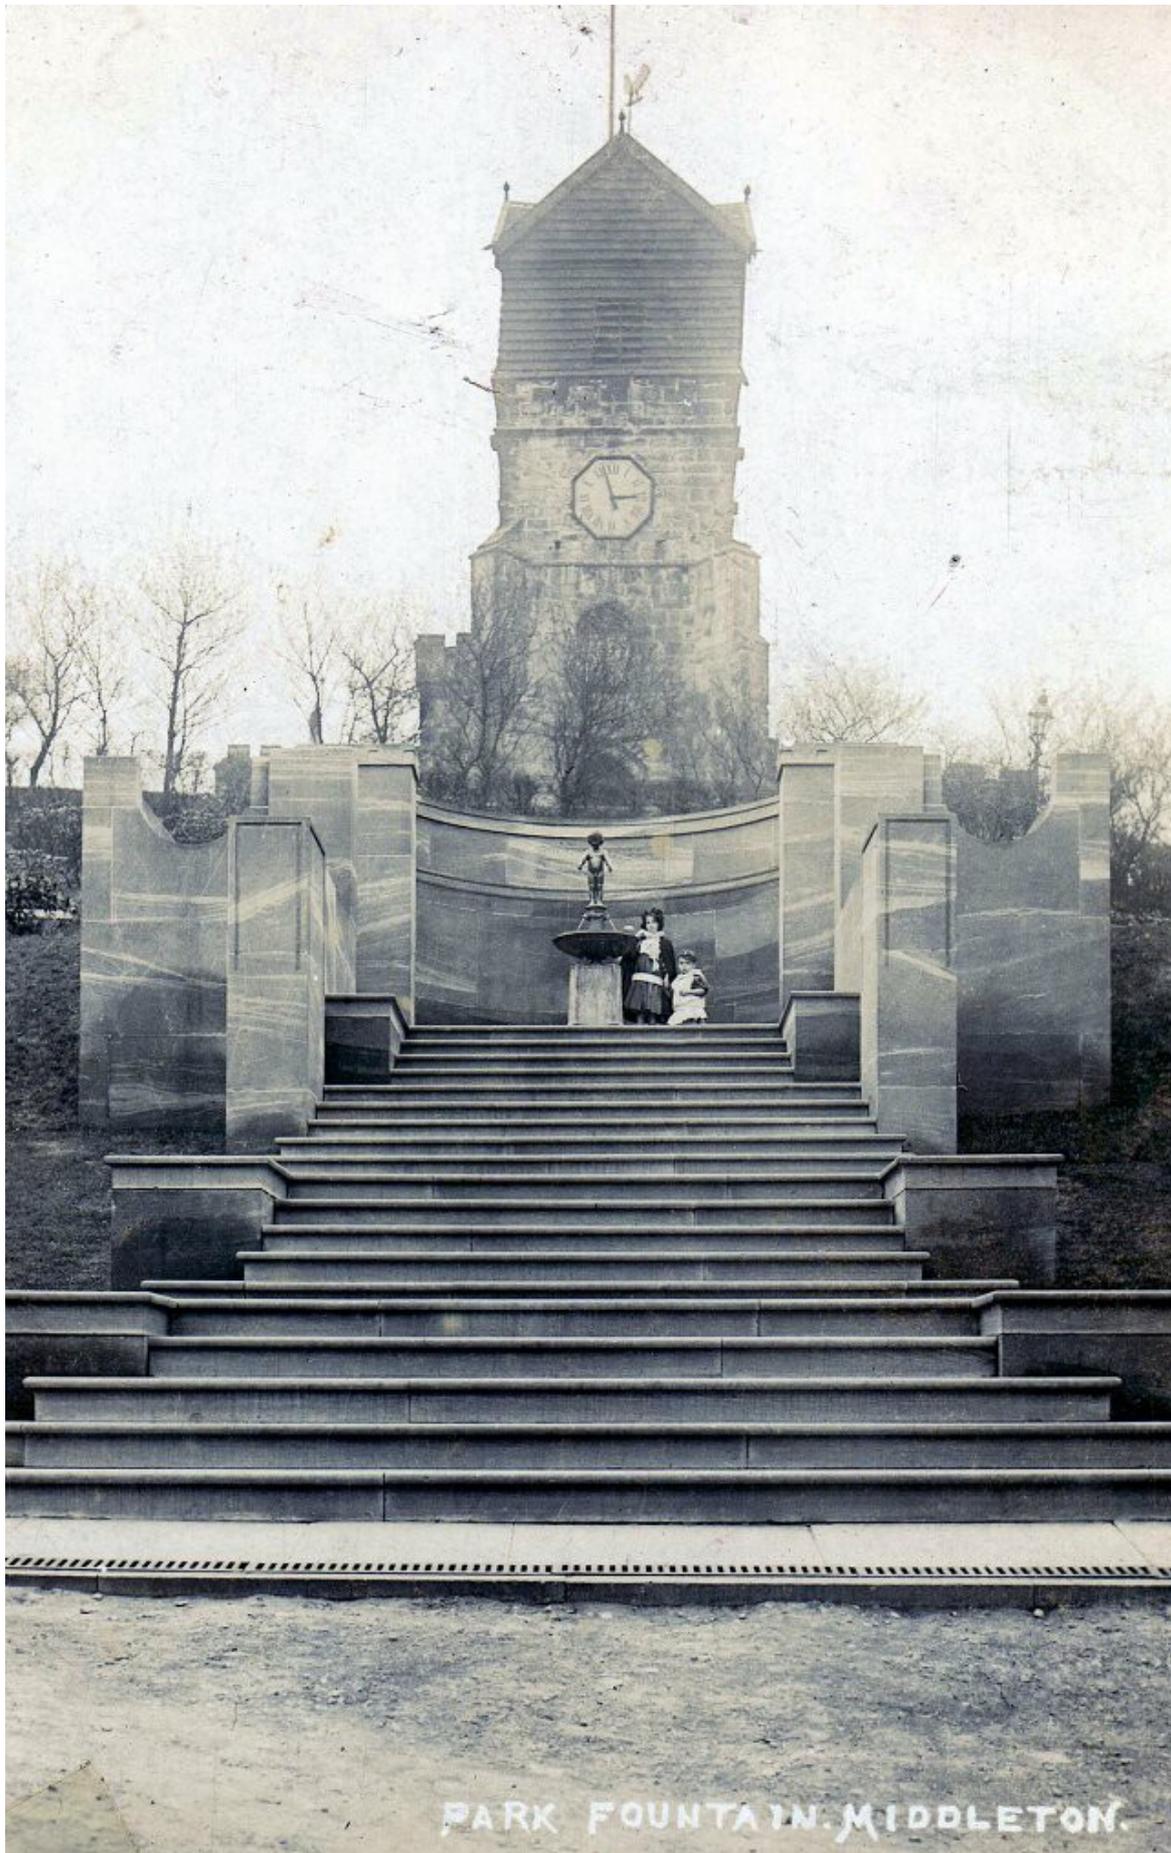
*Illustration 2: Jubilee Park Fountain on completion (Photo: Harold Cunliffe)*

8. The Jubilee Park Fountain was a children's drinking fountain and sculpture set within a roofless loggia-like walled enclosure and elevated on the steep slope of Jubilee Park, leading up to Middleton Parish Church sitting at the top. A substantial formal staircase below the fountain, frames the western aspect of the medieval church and tower. The design is exceptionally ingenious and stylistically advanced. It contains the following inscription in an Arts and Crafts script...

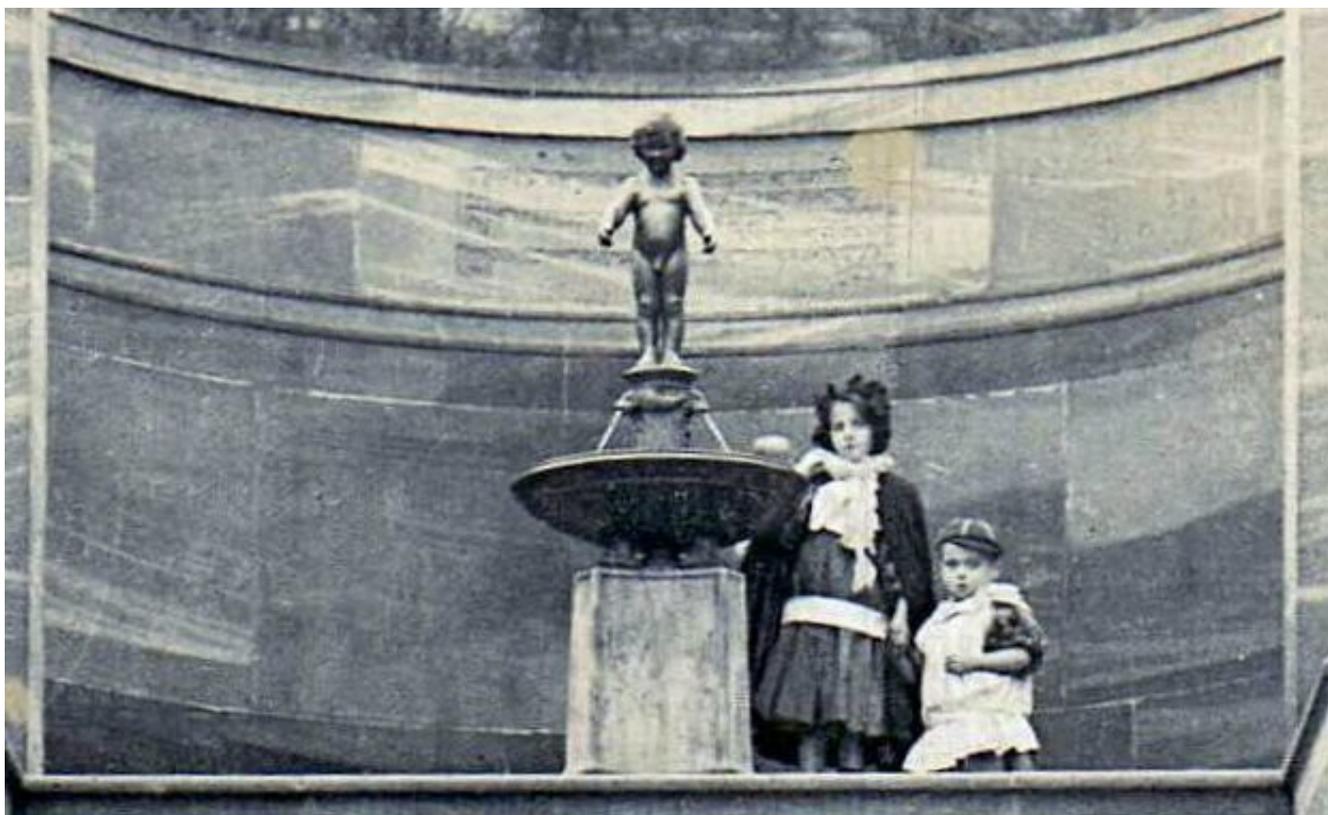
*Illustration 7: Extract of Jubilee Park Fountain on completion (Photo: Harold Cunliffe)*

61. Illustration 19 shows an eroded surface where the face has worn back so the edging groove seen on Illustration 7 has gone, something possible with limestone exposed for several decades. This might have encouraged the postulated over-painting.

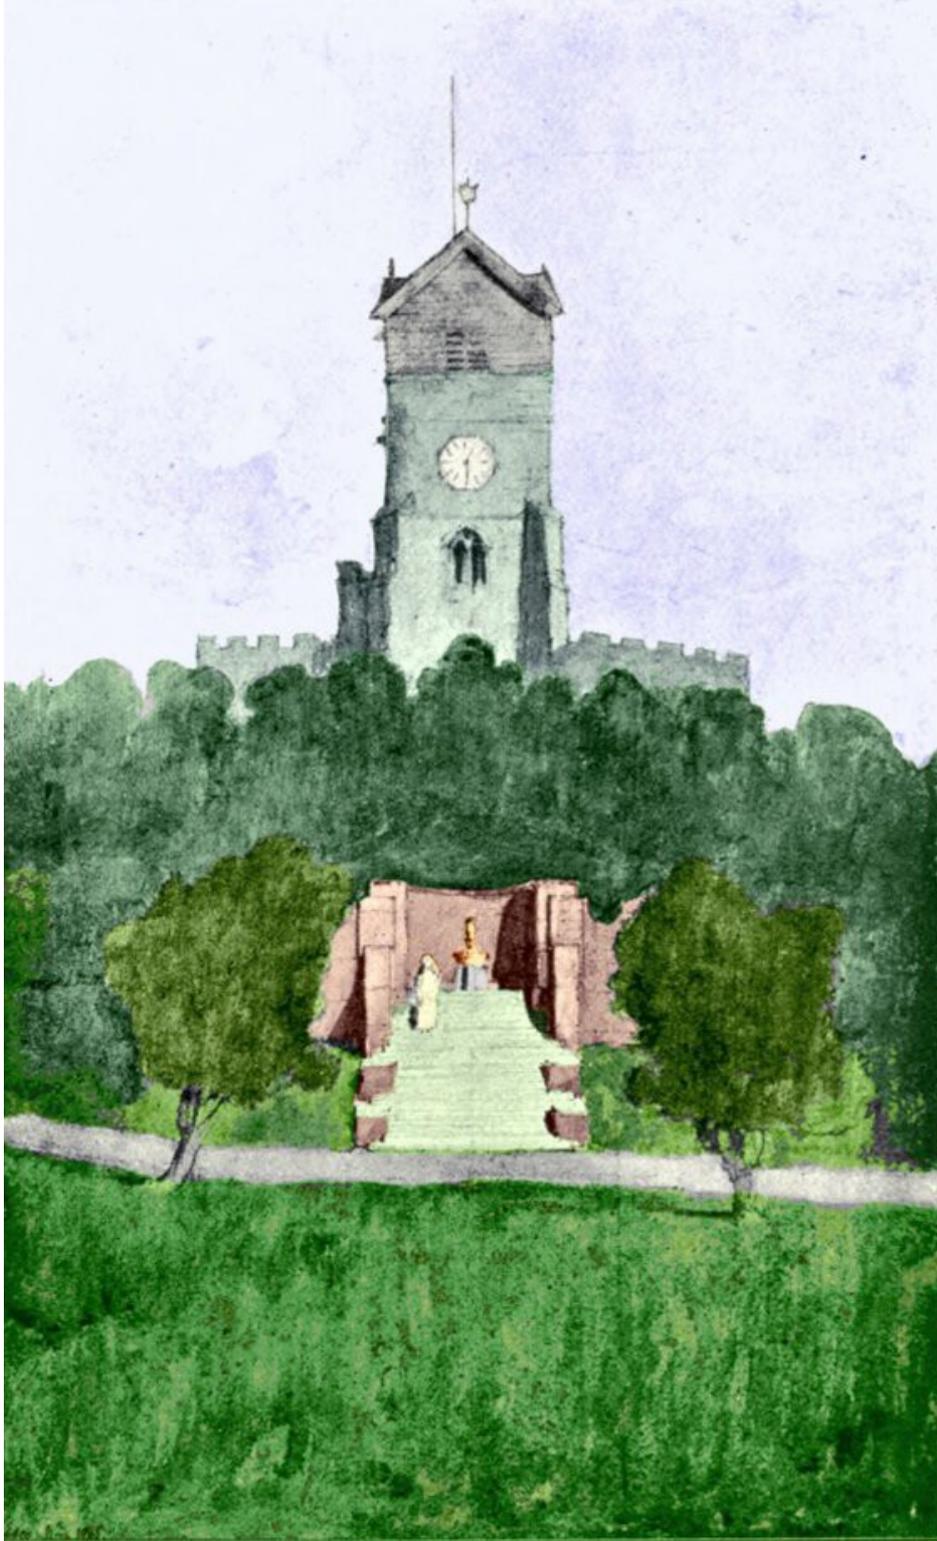
*Illustration 8: Academy Architecture watercolour, hypothetically recoloured*

17. Wood's design for the Jubilee Park Fountain was thus extremely interesting to his contemporaries. It was exhibited at the Royal Academy in 1906 (Illustration 8), something not lost on the *Middleton Guardian*, which reported the matter in May, as the structure was being erected (Appendix 3).
18. Furthermore, the design was used as the frontispiece for the prestigious *Academy Architecture* – the journal which illustrated the most important designs exhibited that year (Illustration 1). Being the cover illustration simply meant that the Jubilee Park Fountain was considered *the* most interesting design exhibited. It provided Park Fountain with immediate national and international prominence.

23. While speculative, Illustration 8, suggests that the reddish stone was meant to stand out against the largely green backdrop (red and green are complementary colours), thus bringing the staircase visually forward in the scene, compared with the larger but more muted parish church.

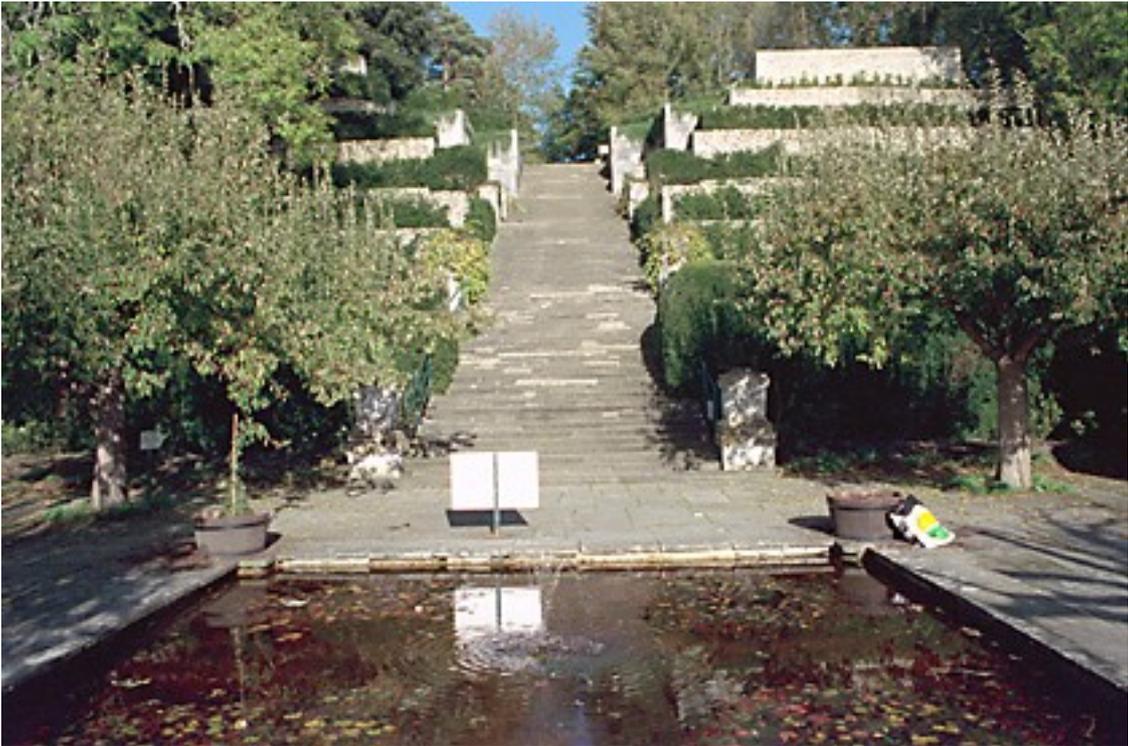
*Illustration 9: Trojan Staircase - before restoration (Photo: Mr George D. Russell)*

27. The Trojan Staircase has been successfully restored (save for the temples) and is now very popular with visitors and for wedding photographs. The restorers wisely addressed the planting associated with the staircase as well as its structure. They completely replaced the surviving damaged shrubs, including the pair of trees at the bottom of the steps. This made an enormous impact (Illustrations 9 & 10).

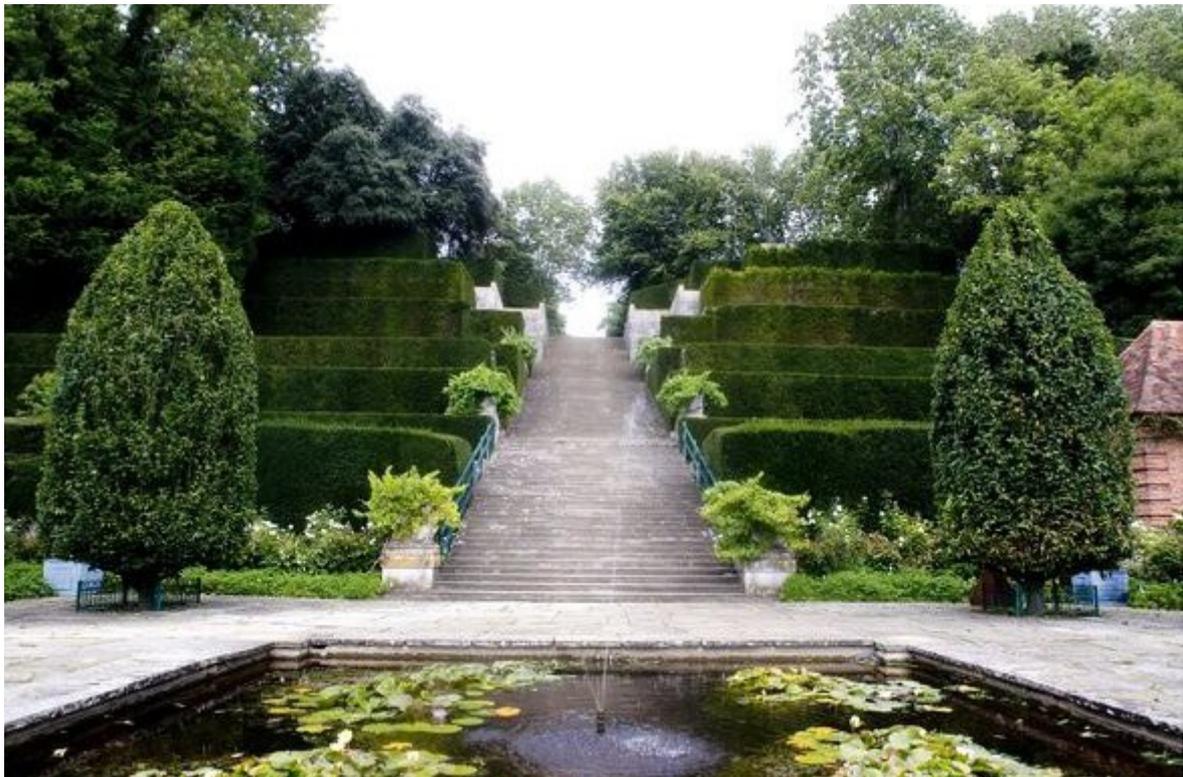
*Illustration 10: Trojan Staircase - after restoration (Photo: Port Lympne Mansion and Gardens)*

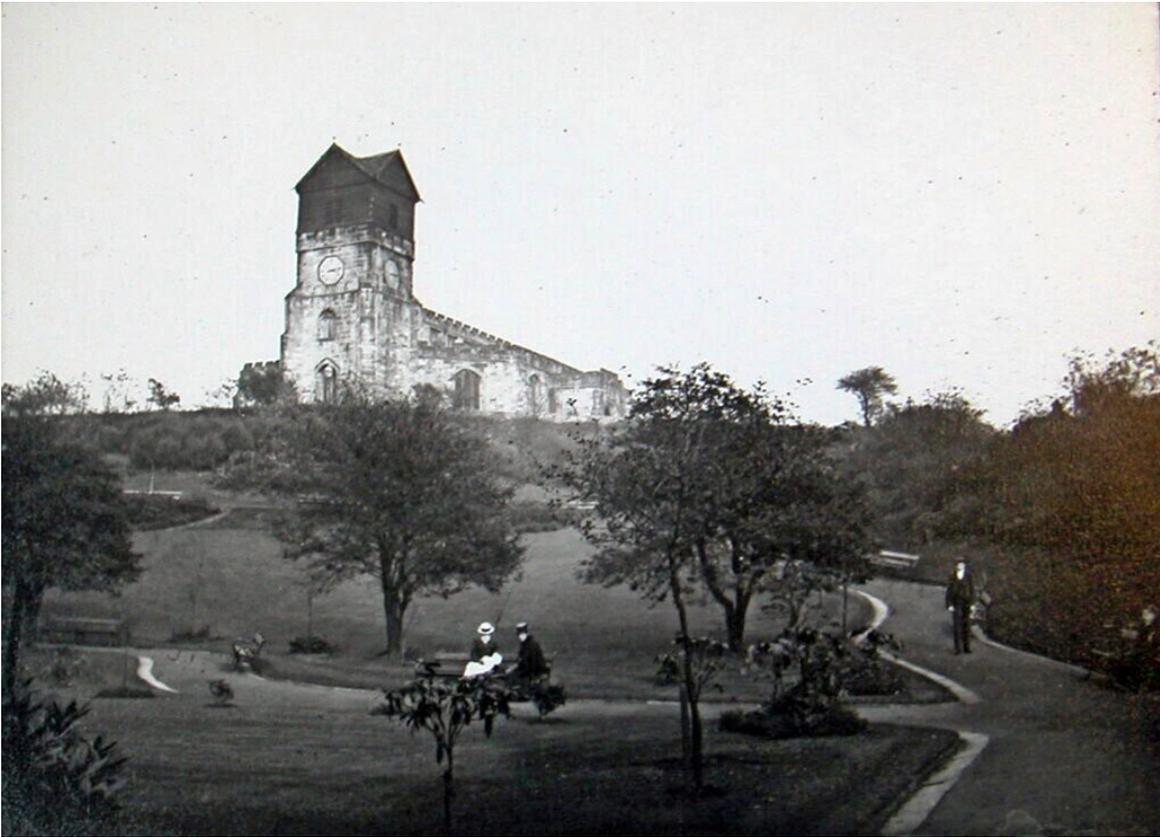
*Illustration 11: Park Fountain c. 1930. Saplings casually planted along path. (Photo: Middleton Library)*

31. Today, the above initial scene is only dimly perceived. Unfortunate changes started early and got steadily worse over the decades (Illustrations 11 to 14 and Appendices 1 and 4). Slowly, casual tree planting and self-seeding completely clogged the scene. Trees planted literally against Park Fountain staircase caused a slight deformation, while new shrub beds hid it from view. Subsequent thinning out simply meant the remaining woodland tree species quickly filled the voids and the modest improvement lasted a very short time.

59. Illustrations 13, 20 & 21 show the plinth and its base as white or very light. However, Illustrations 12 & 13 suggest perhaps the plinth was painted or whitened in some way, as the nearby flood monument (a dull sandstone with lead lettering) is likewise bright white. Such painting of the plinth would be consistent with the need to cover copper sulphate or rust stains.

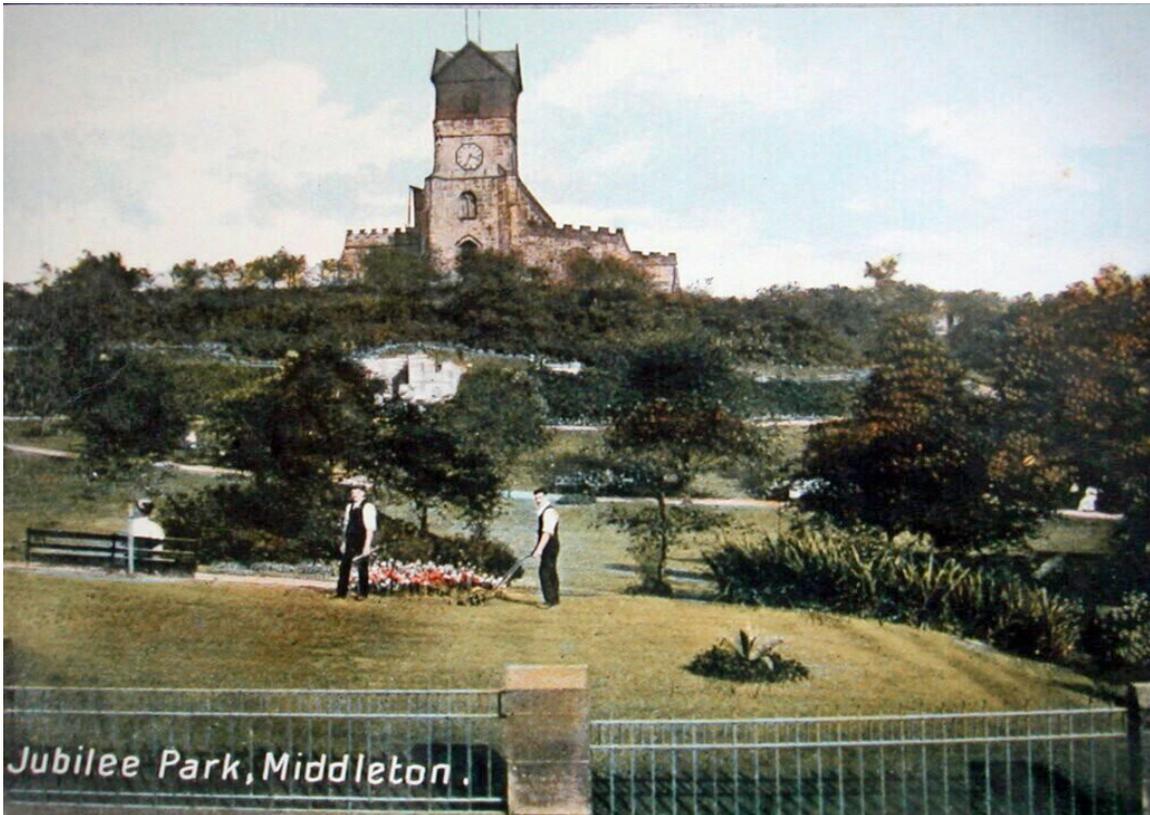
*Illustration 12: Park Fountain c. 1940 Casual and self seeded trees intrude. (Photo: Middleton Guardian)*

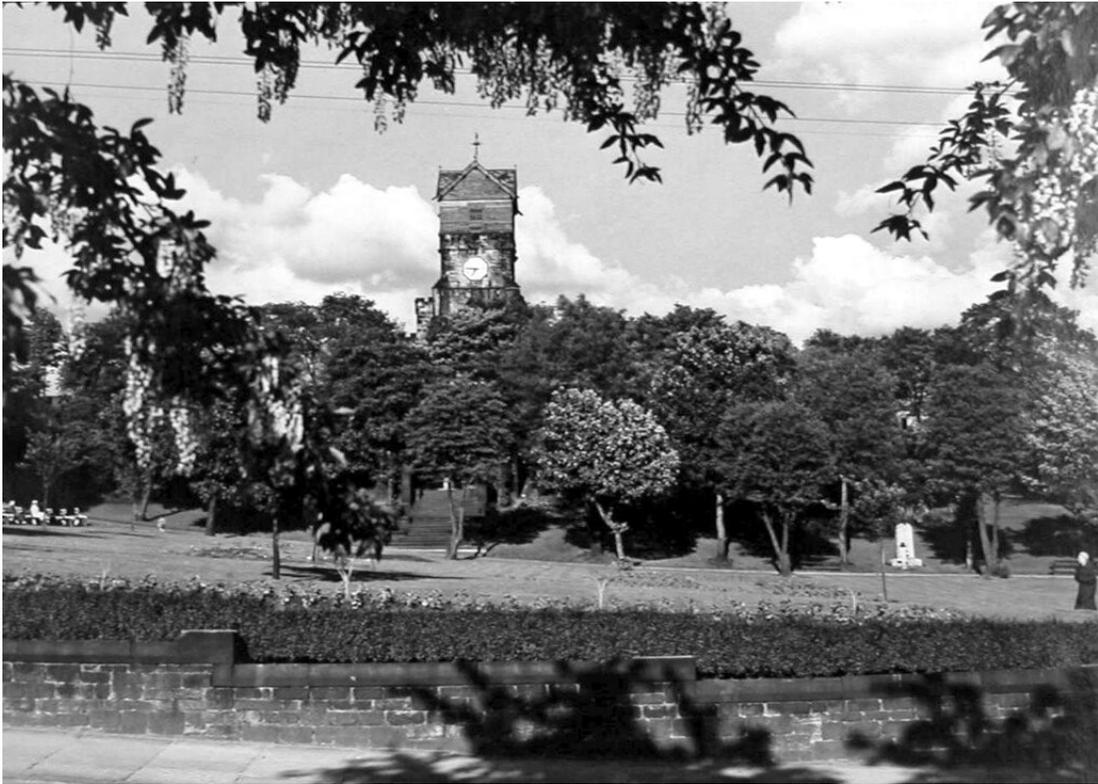
*Illustration 13: Park Fountain c. 1960. Trees completely block the scene. (Photo: Middleton Library)*

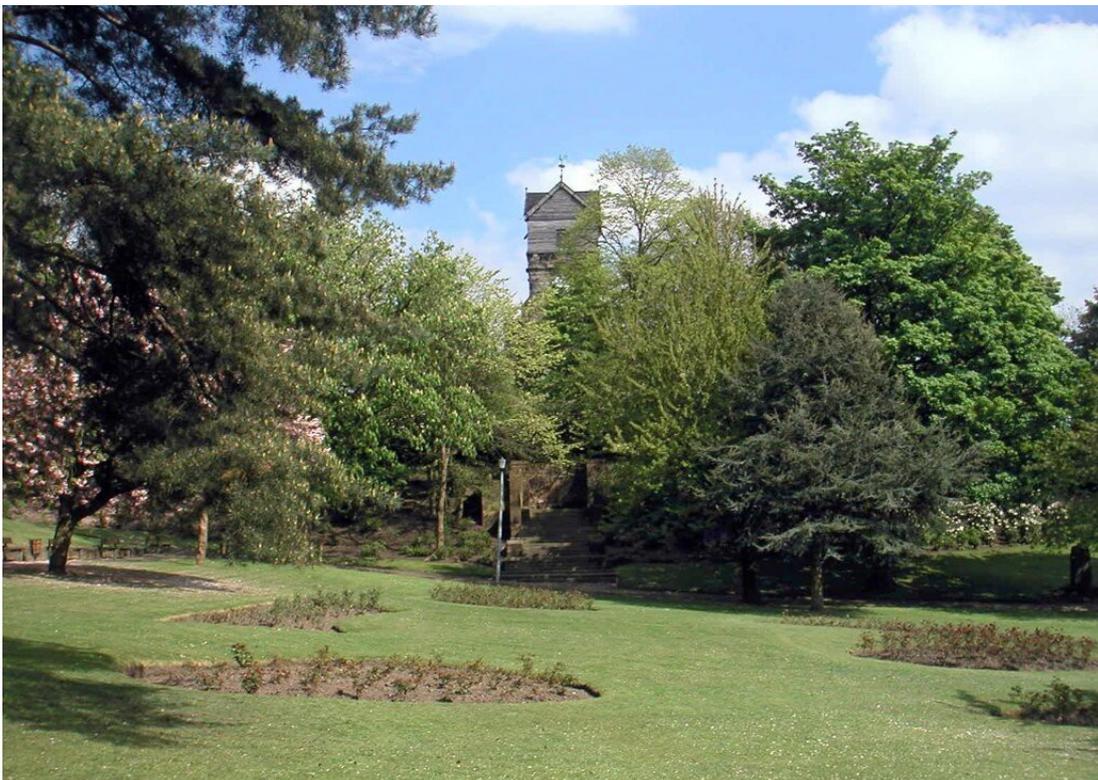
*Illustration 14: Park Fountain 2007. Trees ever larger despite thinning; random species, such as conifers.*

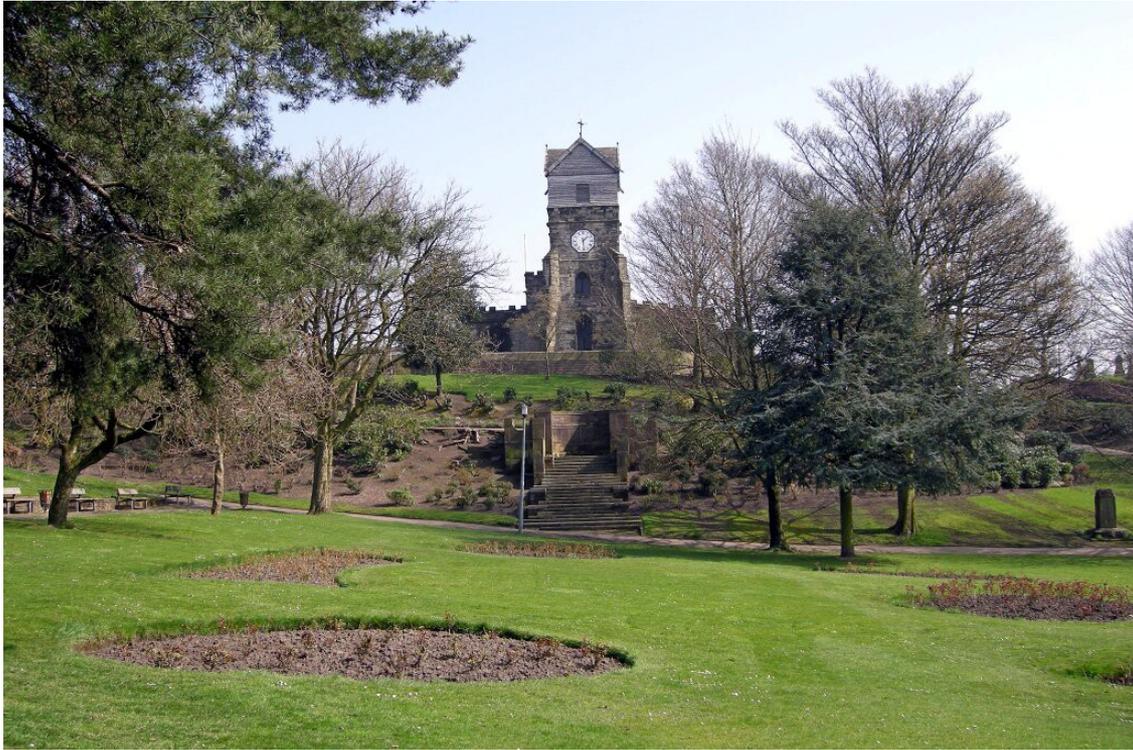
*Illustration 15: Park Fountain 2008. Restoration Phase 1, after campaign by Middleton Heritage Group.*

33. In 2007, both the Fountain and the view of the church remained blocked and ugly. A Phase 1 Restoration Plan was jointly drawn up by Middleton Heritage Group and the Council to address the worst problems. It was implemented over the winter of 2007/8 (Illustration 15). Removing the modern shrub planting on the lawned areas was not addressed and many badly sited trees remained.

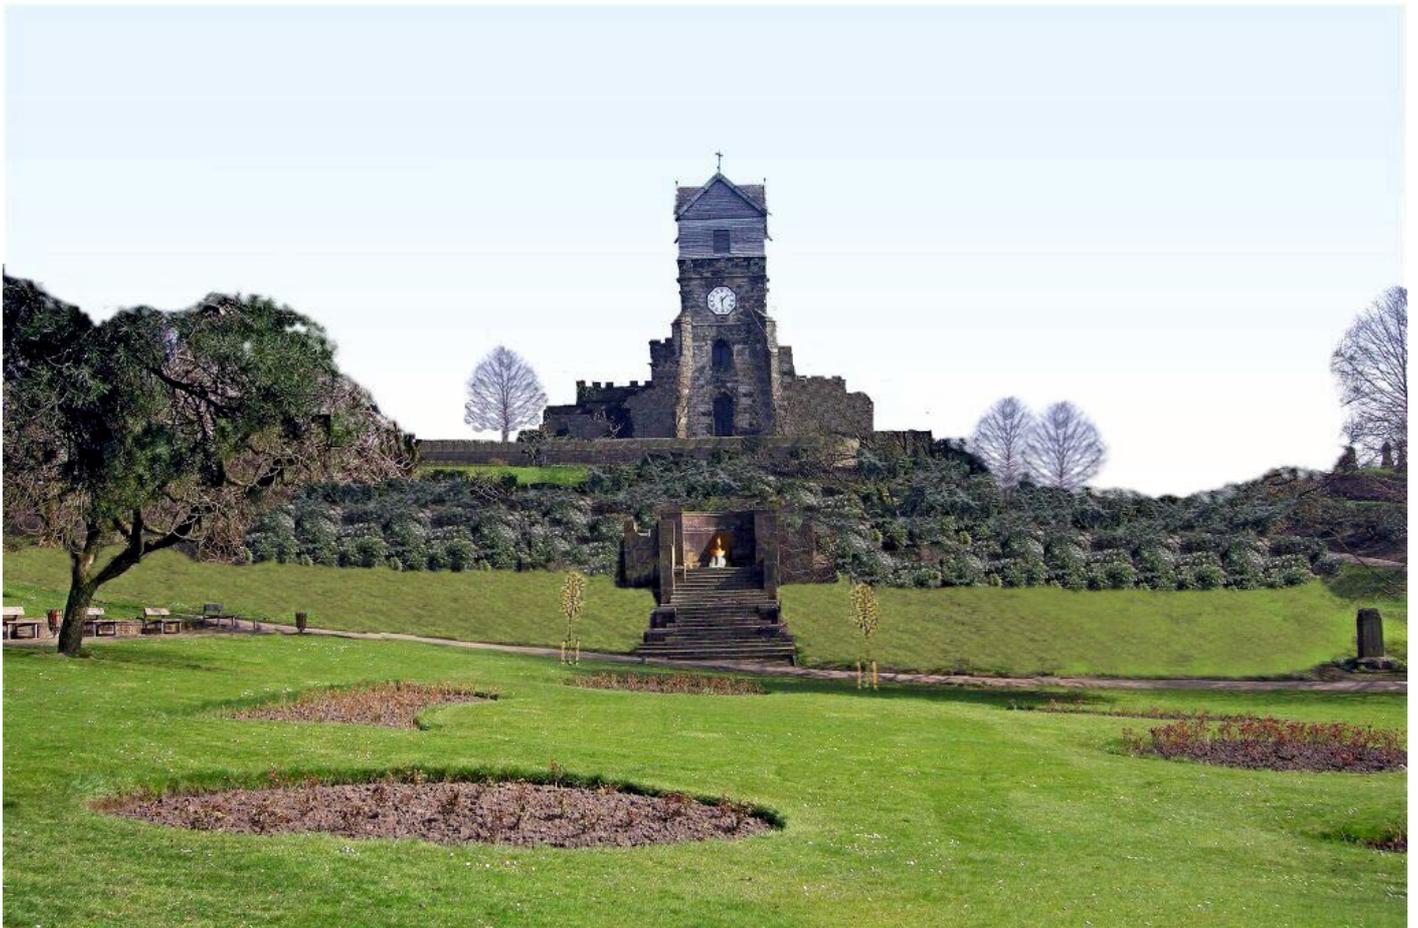
*Illustration 16: Park Fountain 2015? Restoration Phase 2, THI restores the Edgar Wood scheme.*

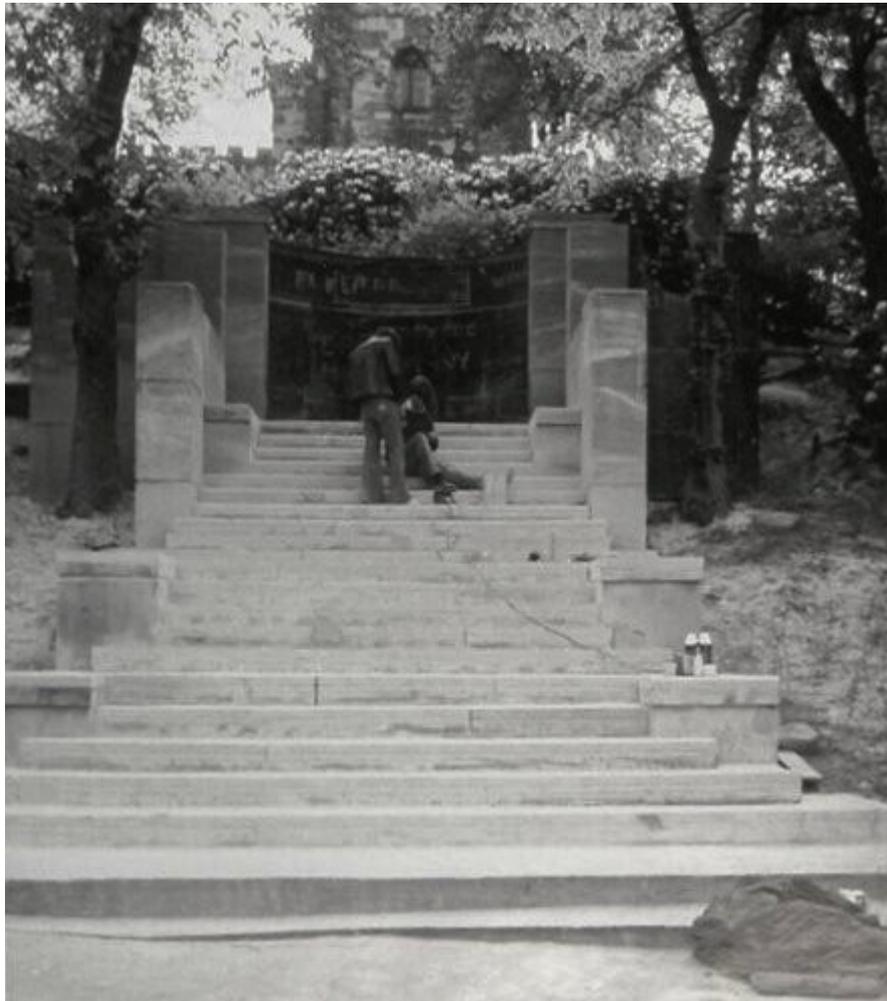
*Illustration 17: Sandblasting and removing nosings 1978. Trees about. (Photo: Middleton Library)*

74. The repair of the monument is not part of this advice, unless it impacts on the restoration. This is the case with regard to cleaning work.
75. The structure has been sandblasted, so the surfaces are now gritty and have attracted moss, lichen and mould from the nearby trees. Most were largely cut down in early 2008 but dark green moss and pale green lichen are now prominent on the structure. In key places, such as the exedra and its inscription, there is also a black carbon layer and historic graffiti only partially removed. There are also areas of recent small scale graffiti.

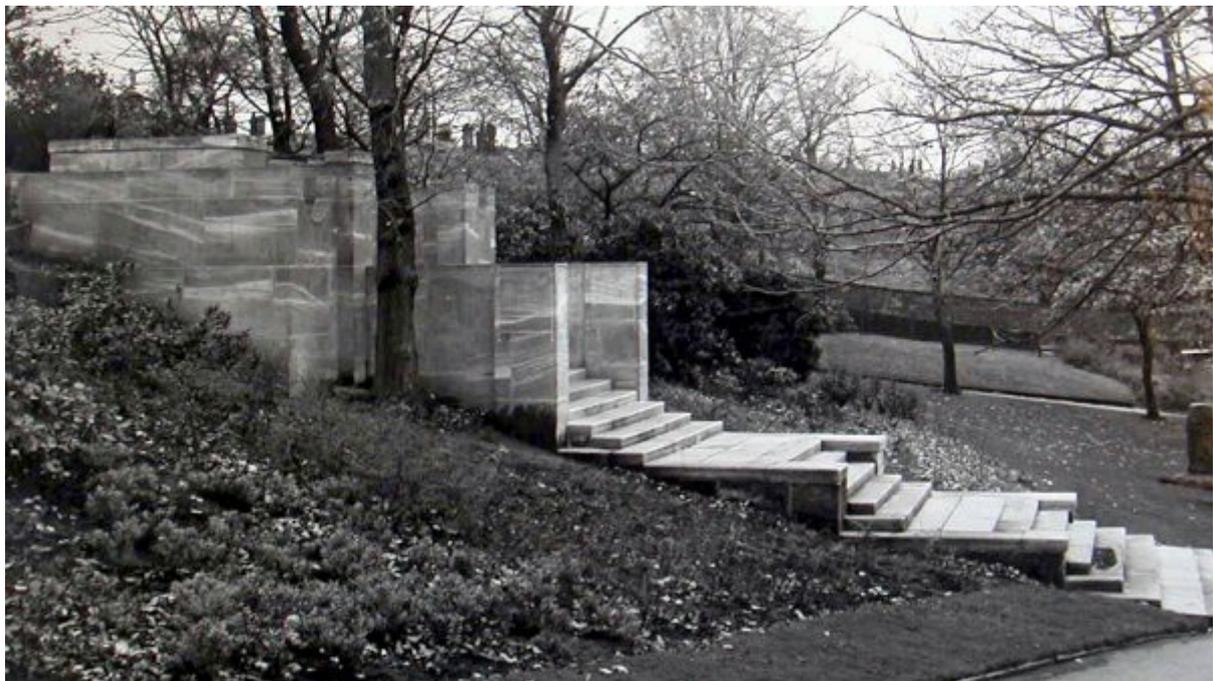
*Illustration 18: Lawns either side were planted with shrubs (Photo: Middleton Library)*

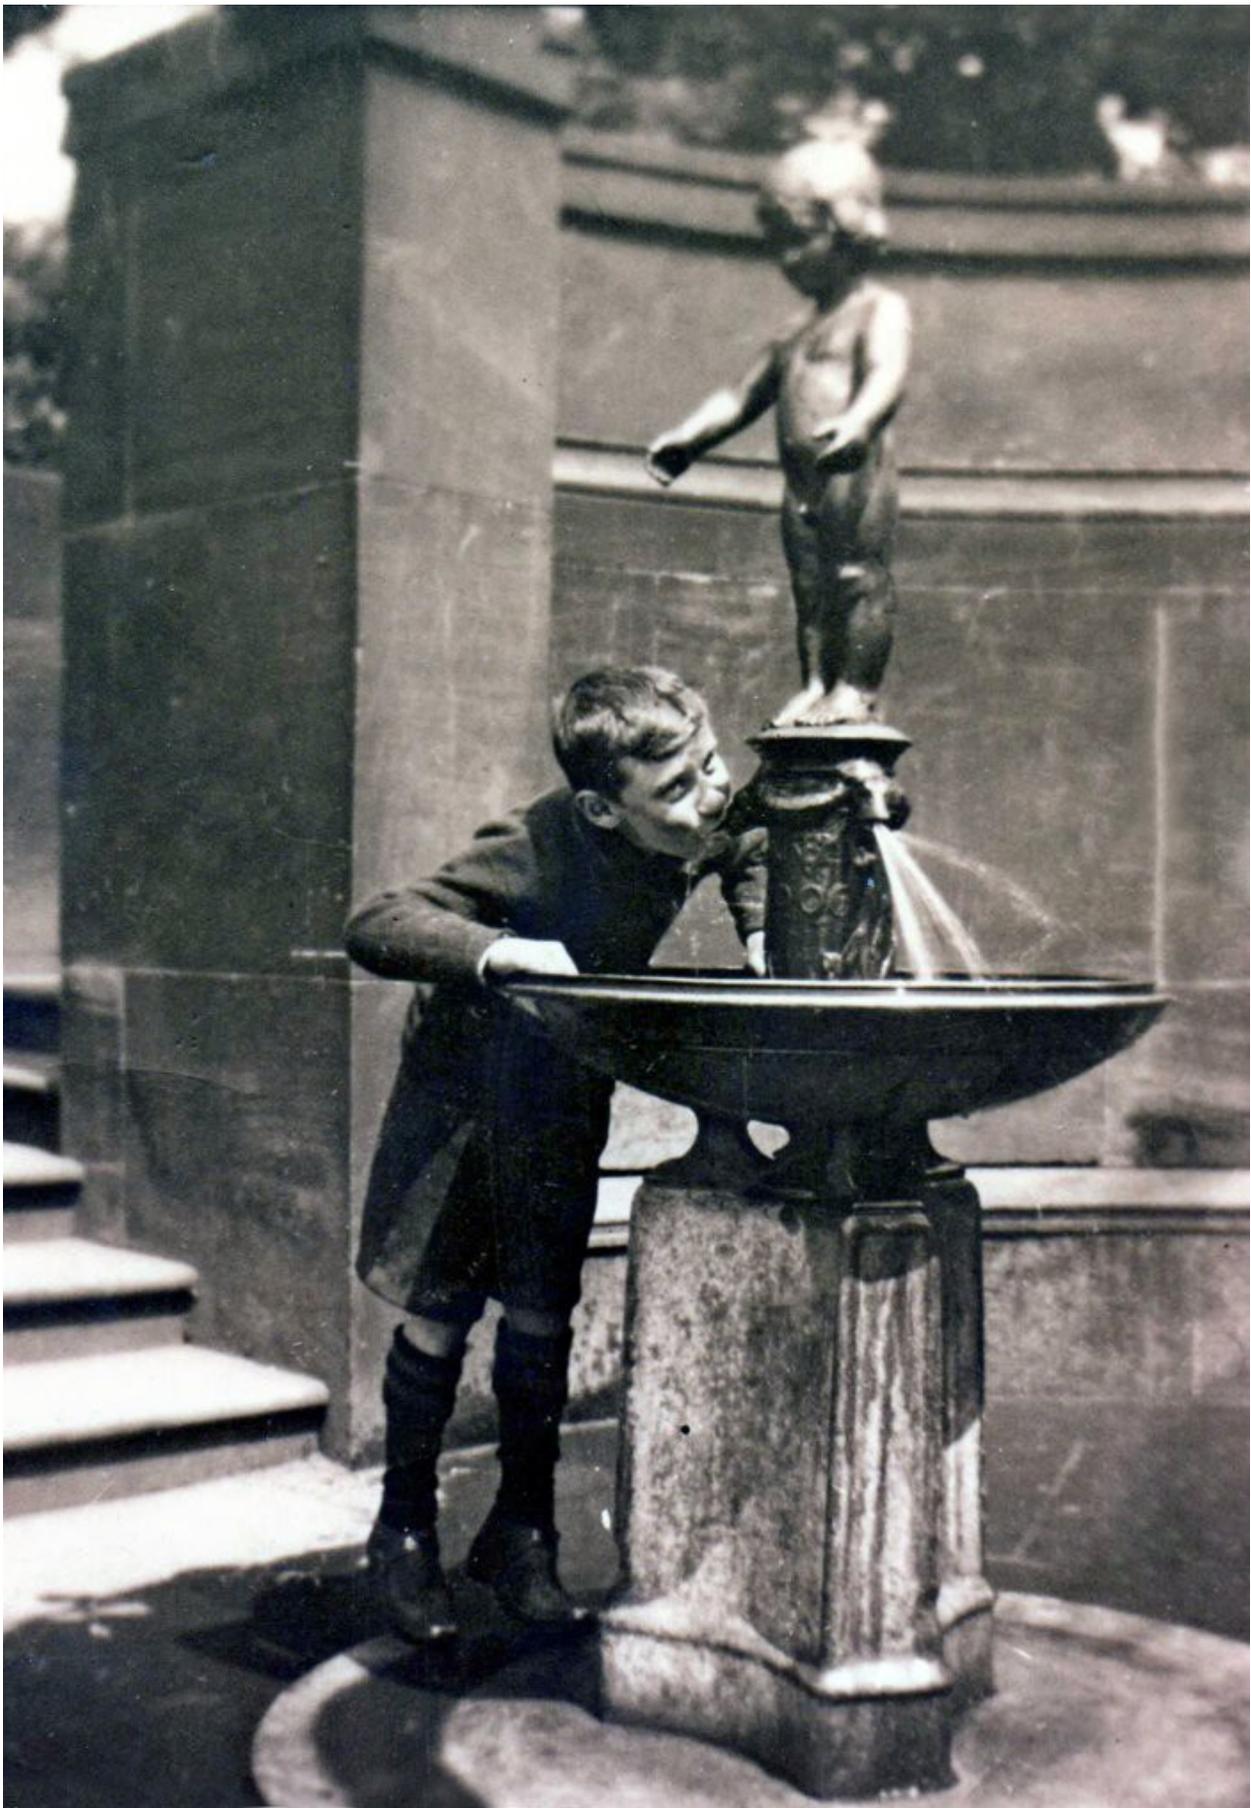
*Illustration 19: Mid-Twentieth Century Photograph 1 (Photo: Harold Cunliffe)*

39. The drinking fountain was a small child-sized structure comprising the following (Illustrations 19 to 21)...
- a) a wide circular base slightly raised off the ground,
  - b) a 'moderne' styled plinth, scalloped to create three projections,
  - c) topped by a wide flat bowl with three matching squat legs, through which the water must have drained,
  - d) with a small 'post-box' shaped pedestal rising from the centre of the bowl, ornamented with *TBW 1906* and Art Nouveau plant forms, from which water shoots downwards from the mouths of three fish-shaped drinking fountains, two at the front and one at the rear, their fish bodies wrapped around the top of the pedestal.
  - e) This supported a small statue of a boy, not quite a cherub, the focal point of the composition.
  - f) Water for drinking ran constantly in the manner of a true fountain - there were no taps.

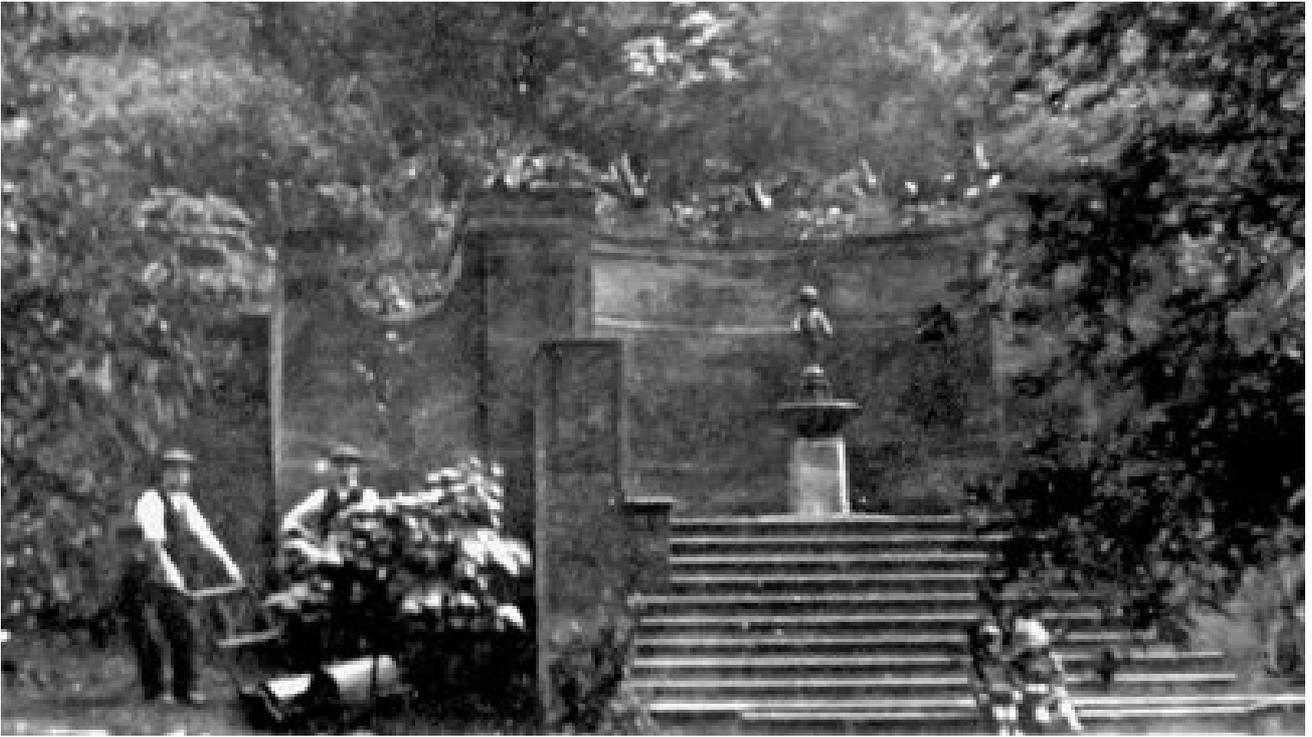
*Illustration 20: Mid-Twentieth Century Photograph 2 (Photo: Harold Cunliffe)*

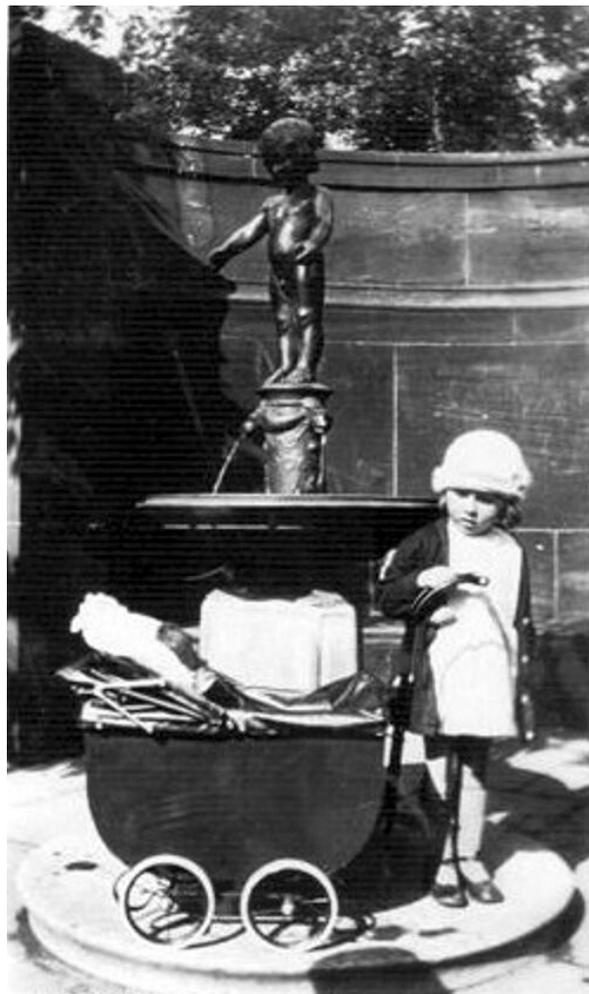
*Illustration 21: Mid-Twentieth Century Photograph 3 (Photo: Harold Cunliffe)*

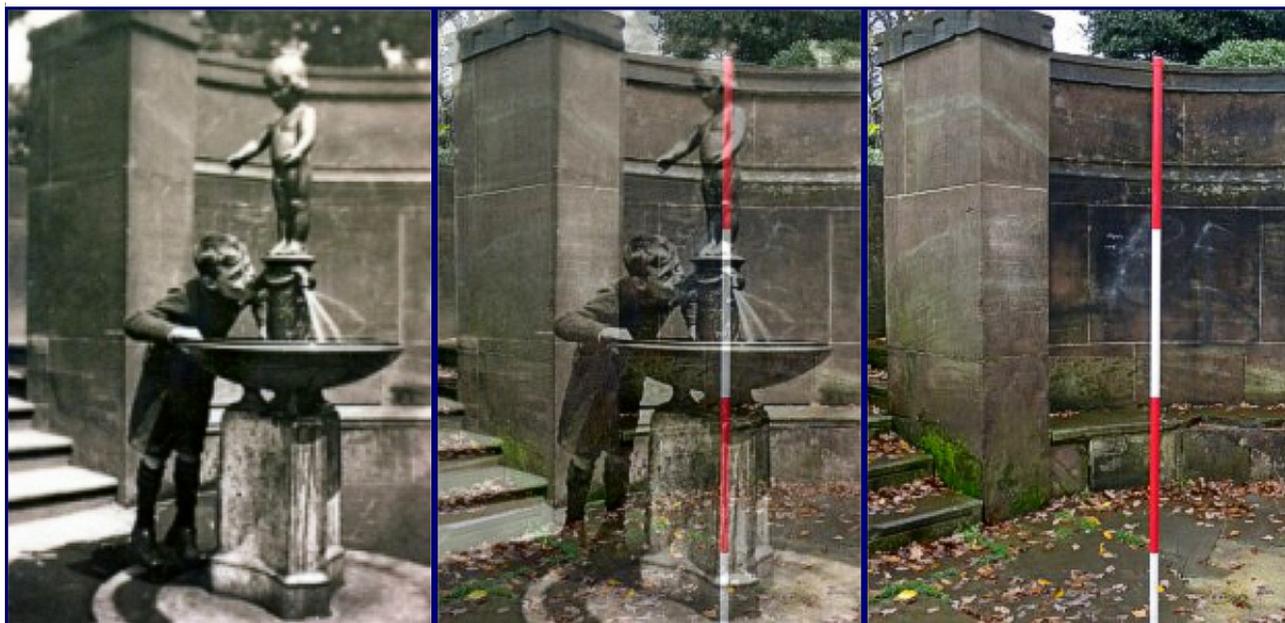
*Illustration 22: Dimension Technique Rehearsal 1*

52. (Illustrations 22 & 23) show a rehearsal of the technique using a less accurate ranging pole. At the

first attempt, the original viewing point was very nearly achieved, despite poor weather conditions, meaning an exact match should be possible. The Edgar Wood Society is happy to undertake this work if desired by the THI manager or consultant surveyor.

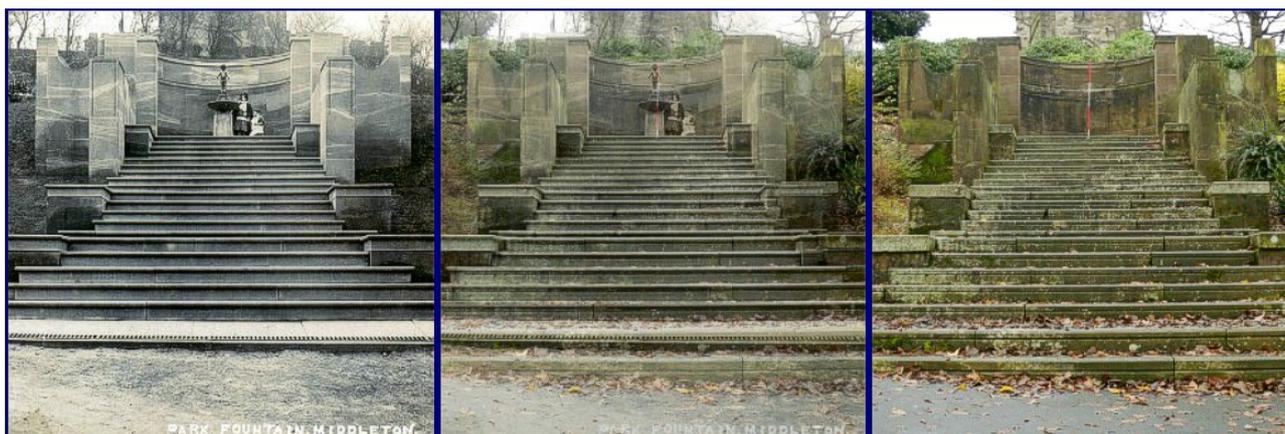
*Illustration 23: Dimension Technique Rehearsal 2*

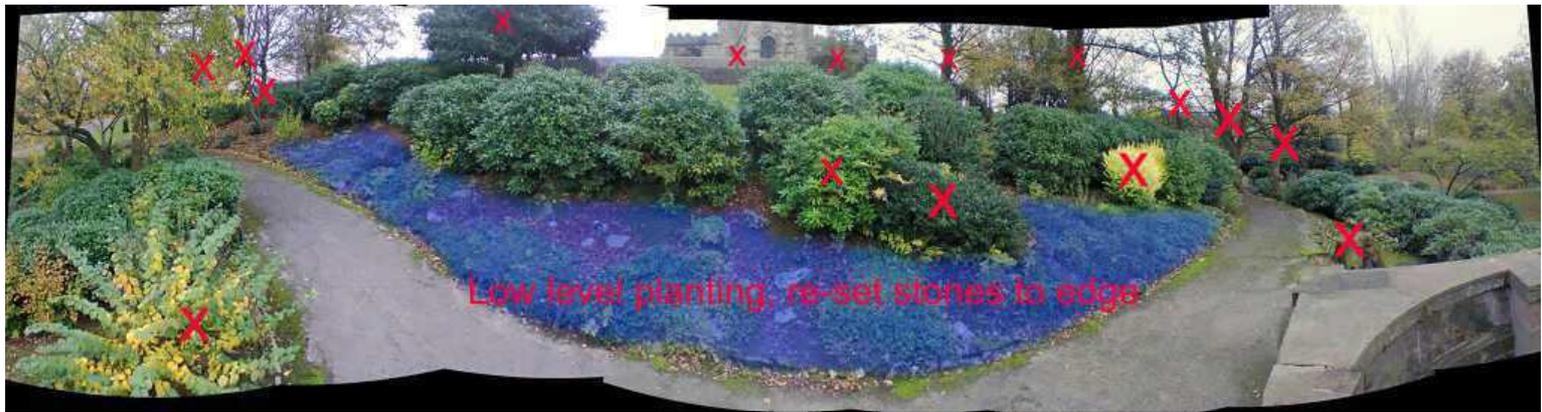
*Illustration 26: Top path, tree and shrub removal, low limestone wall and low level planting*

82. The top pathway has considerable potential and should be restored to its original quality by new low level planting to the open area behind the Fountain, solving the drainage issues, repairing the pathway surface, edges and slopes adjacent the Fountain, and, recreating the low limestone wall around the edge of the rhododendron planting, if this is possible (Illustration 26).
