Edgar Wood and Middleton Townscape Heritage Initiative

## Jubilee Park Fountain, Middleton - Advice on Restoration

17<sup>th</sup> January 2015

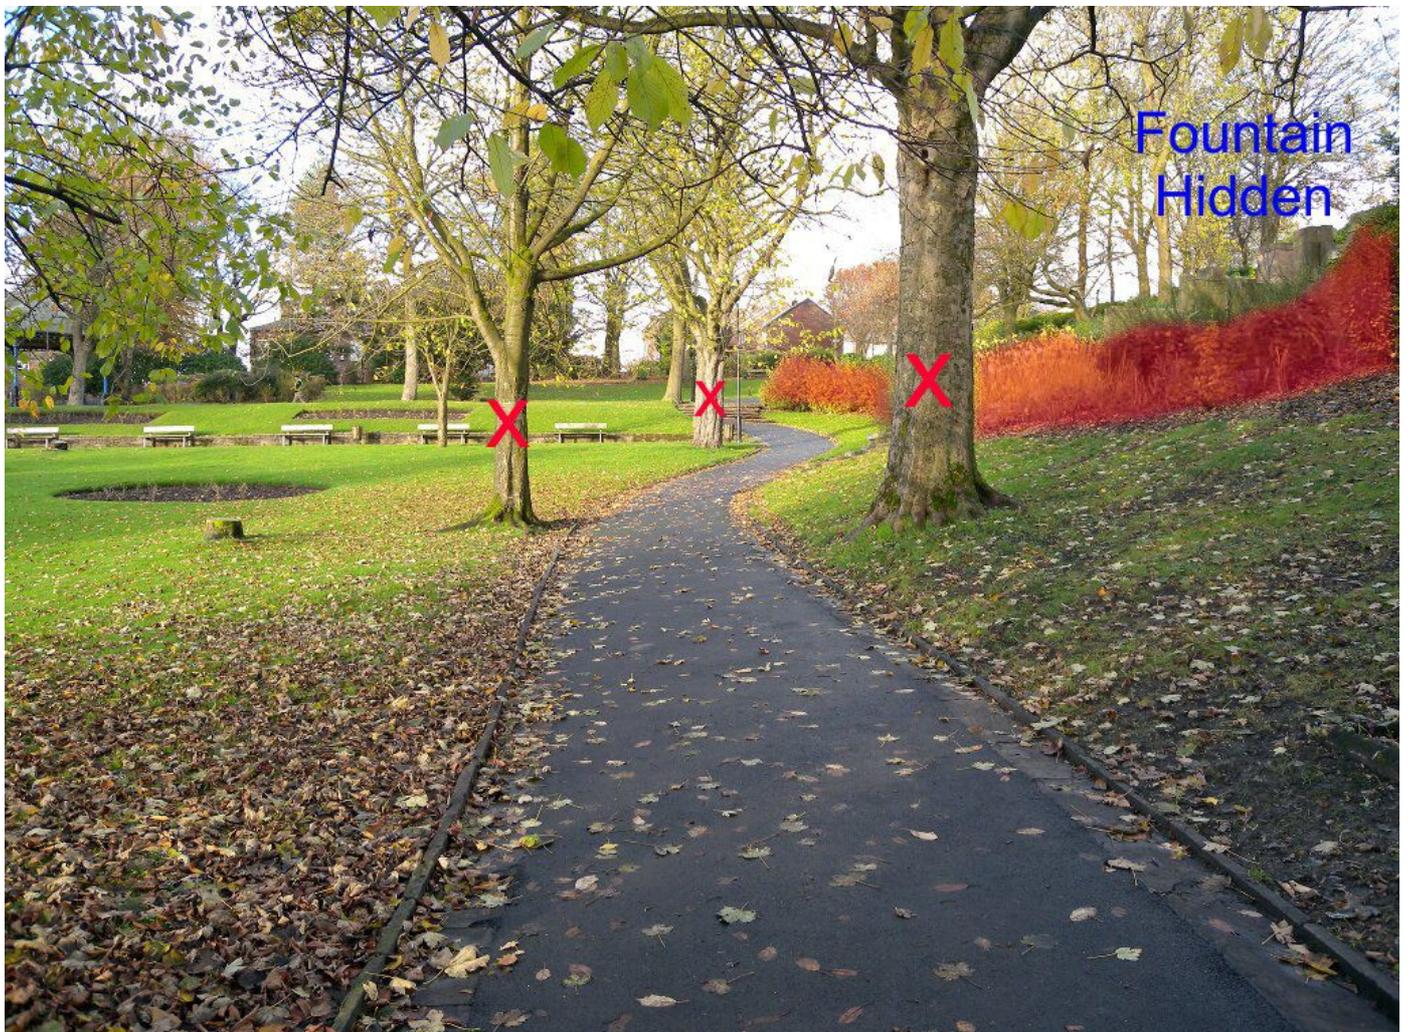
*Illustration 27: Bottom path, the staircase is hidden by tree and shrub planting when approached.*

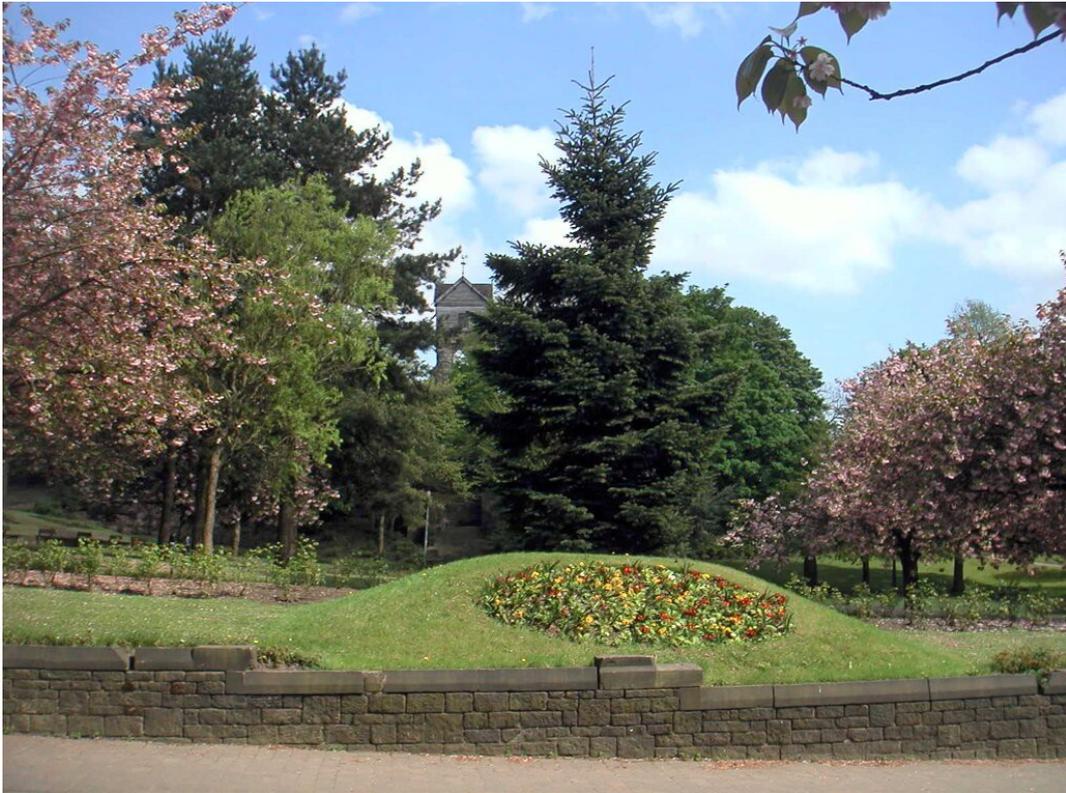
*Illustration 28: Long Street Axis 2007, the church tower is just visible*

86. The above mentioned conifers and the ever bigger Christmas tree now completely block the axial views to the Fountain and Church from Long Street (Illustrations 28 & 29). A new Christmas tree should be planted on a new site. A better location in the park would be near the New Lane corner.

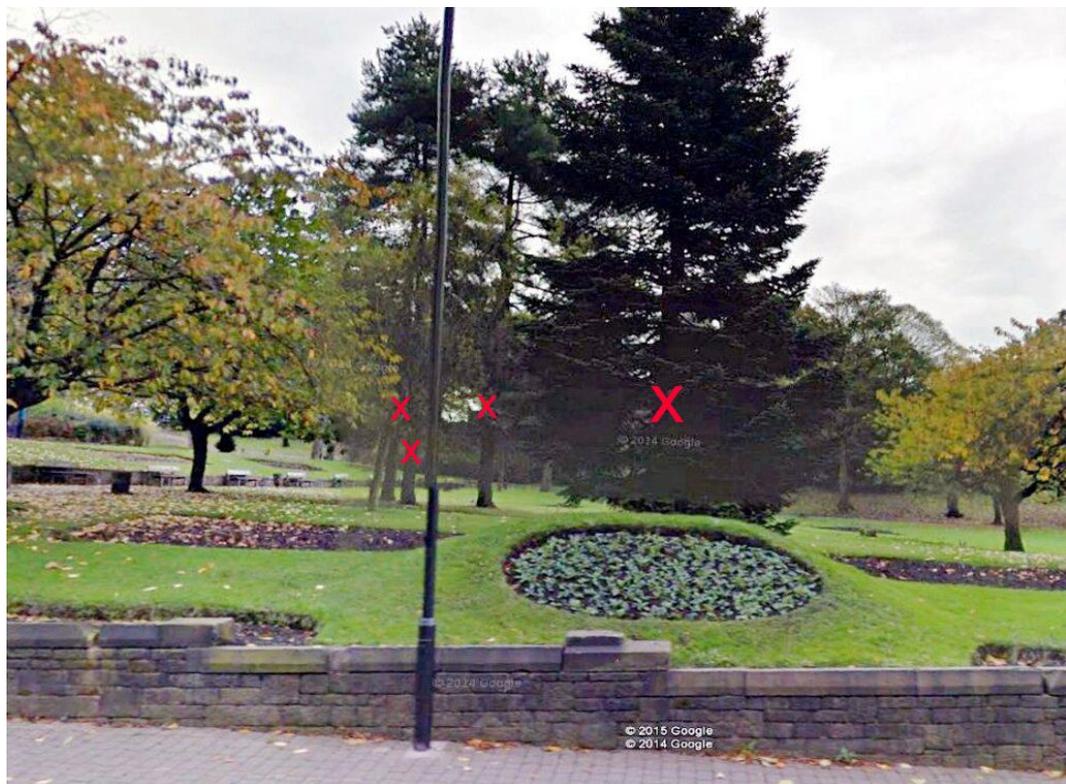
*Illustration 29: Long Street Axis 2013, views blocked and made ugly by conifers. (Google Earth)*

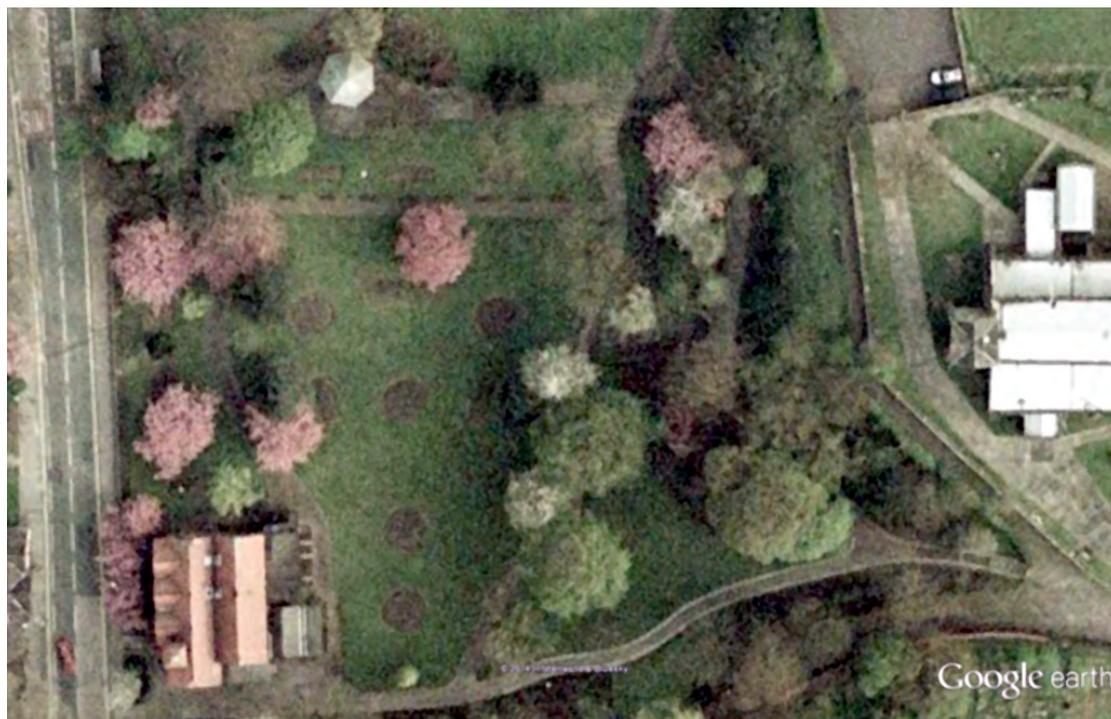
*Illustration 30: 2005 Pink cherry trees frame the view of the Fountain from Long Street. (Google Earth)*

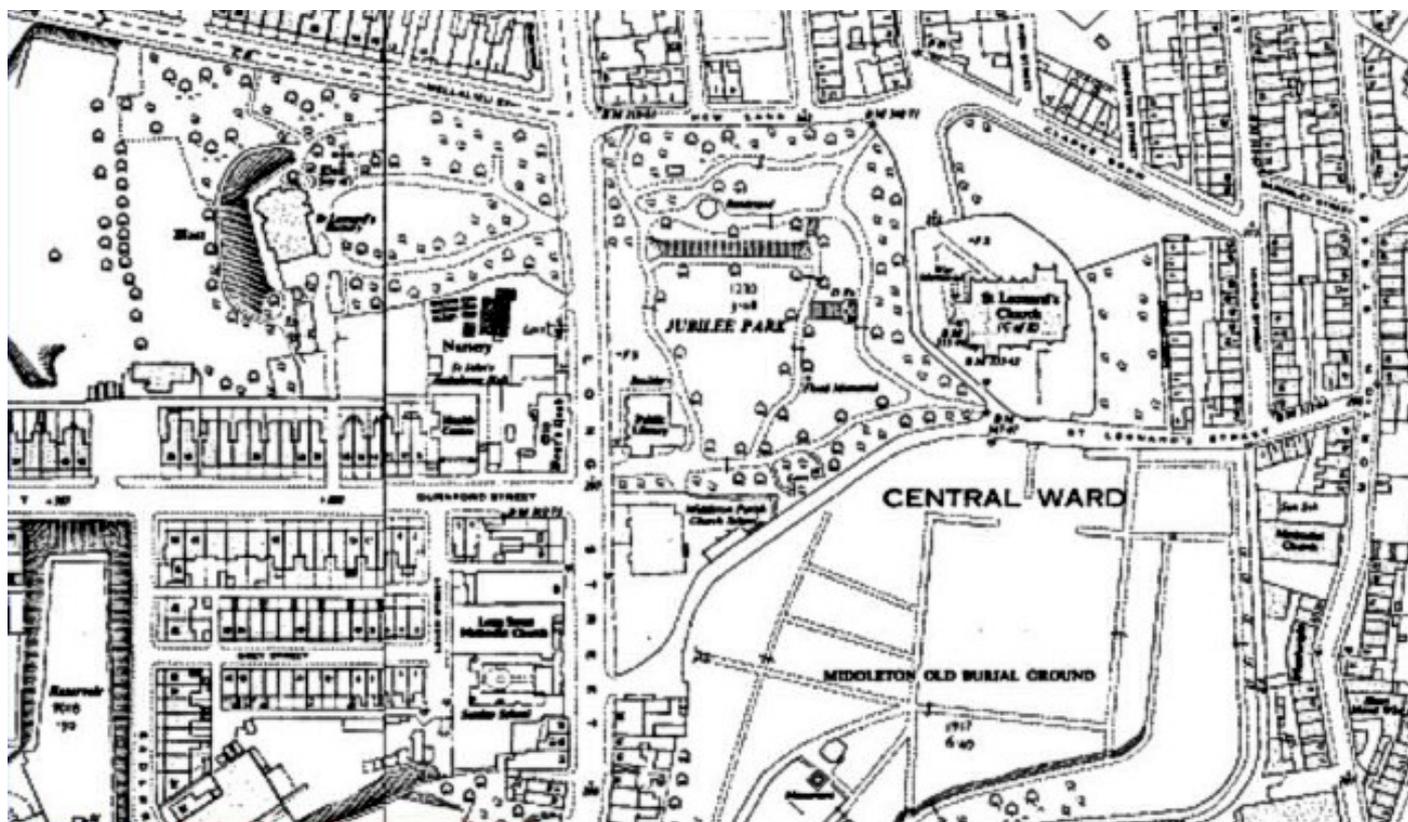
*Illustration 31: 1955 The sunken area has gone and Wood's lower path is tree-lined. (Ordnance Survey)*

32. Not all changes were harmful. Originally the main park lawn had a sunken valley which was later filled and the flower beds added. Wood's lower path to Park Fountain was banked up along the edge and may have been slipping into it. Cracks and distortions on the path are still visible today.

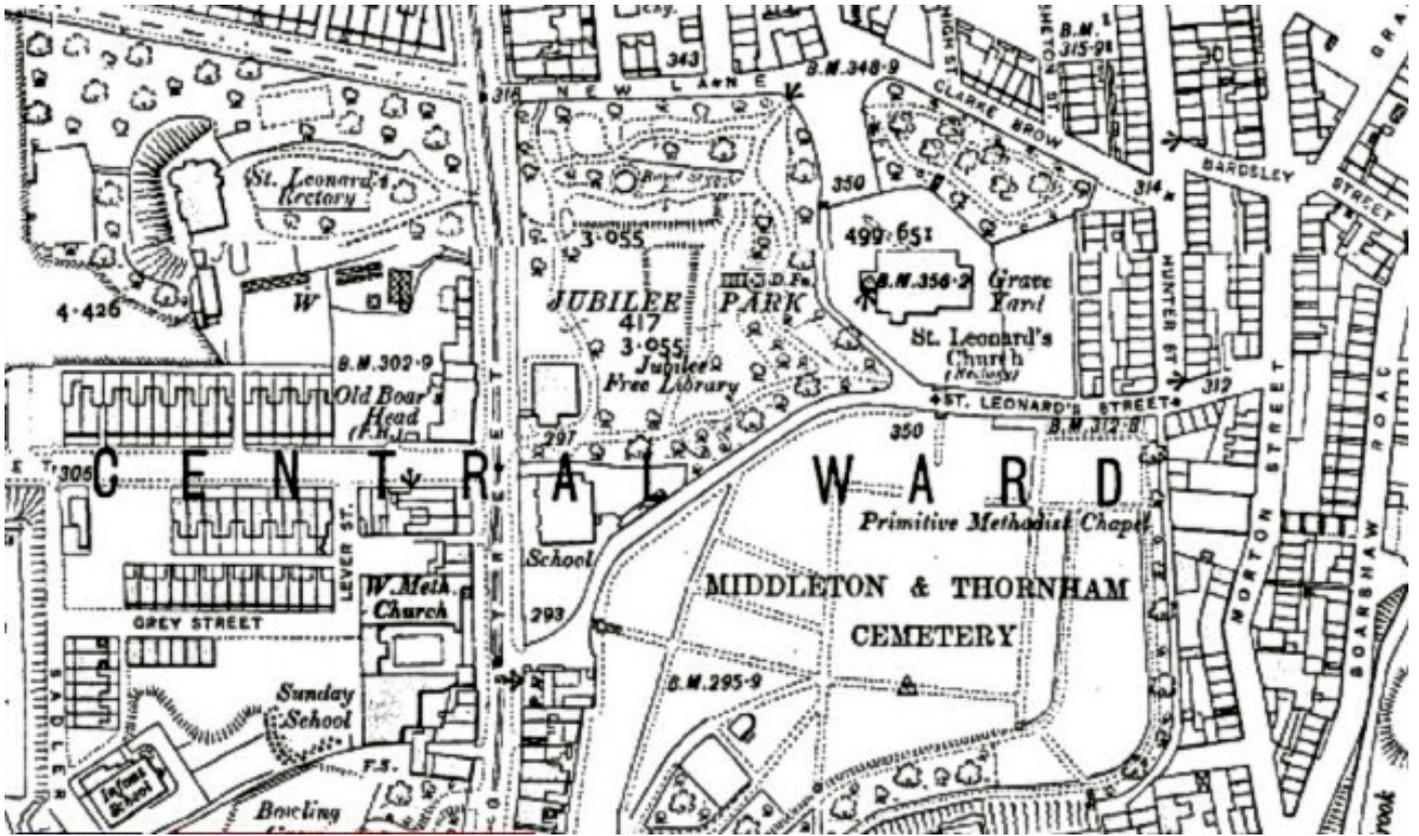
Illustration 32: 1909 The Fountain is installed with a footpath and rhododendron beds. (Ordnance Survey)

1. The outline history can be followed on the map regression in Appendix 1. In 1905/6 Edgar Wood installed the fountain and staircase and planted linear beds of rhododendrons either side (at the top of the slope). A picturesque lower path was constructed along the edge of the sunken area to access the bottom of the staircase (Illustrations 32 and 33). The above photo shows a stony gravel path, very like the ones Wood used at Long Street Church and School nearby and his larger houses.

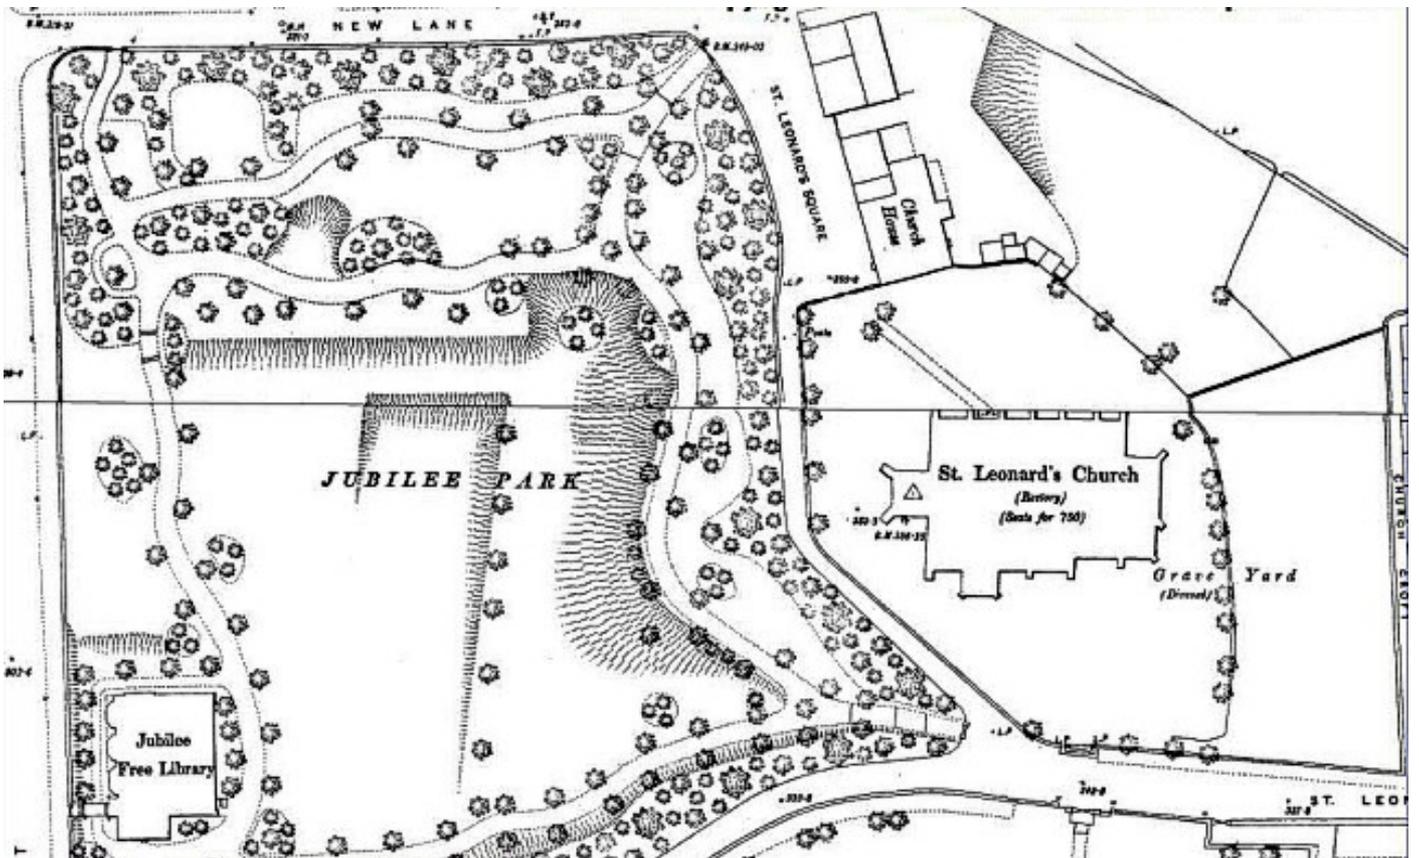
Illustration 33: 1891 Pre-Fountain, Wood removed the trees next to the sunken area. (Ordnance Survey)
